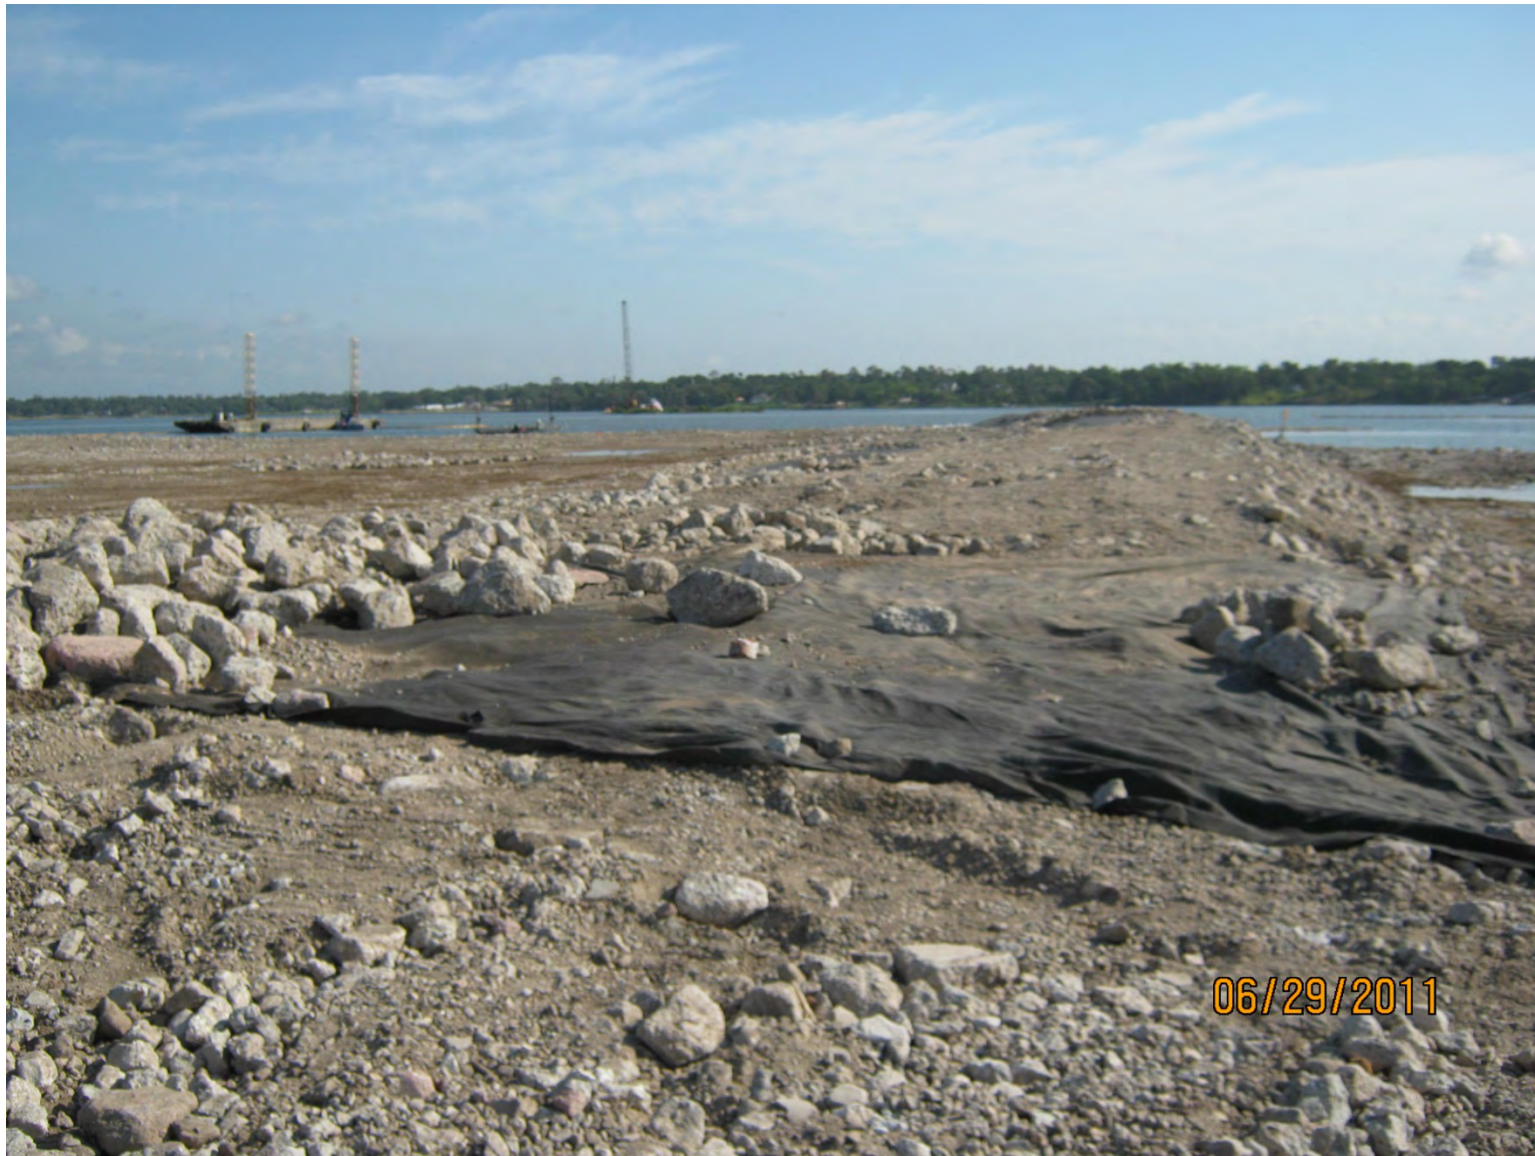
Final layer of geotextile before being covered with last layer of armor stone on the stockpile area. Looking north along the central berm. Note armor stone under geotextile fabric.

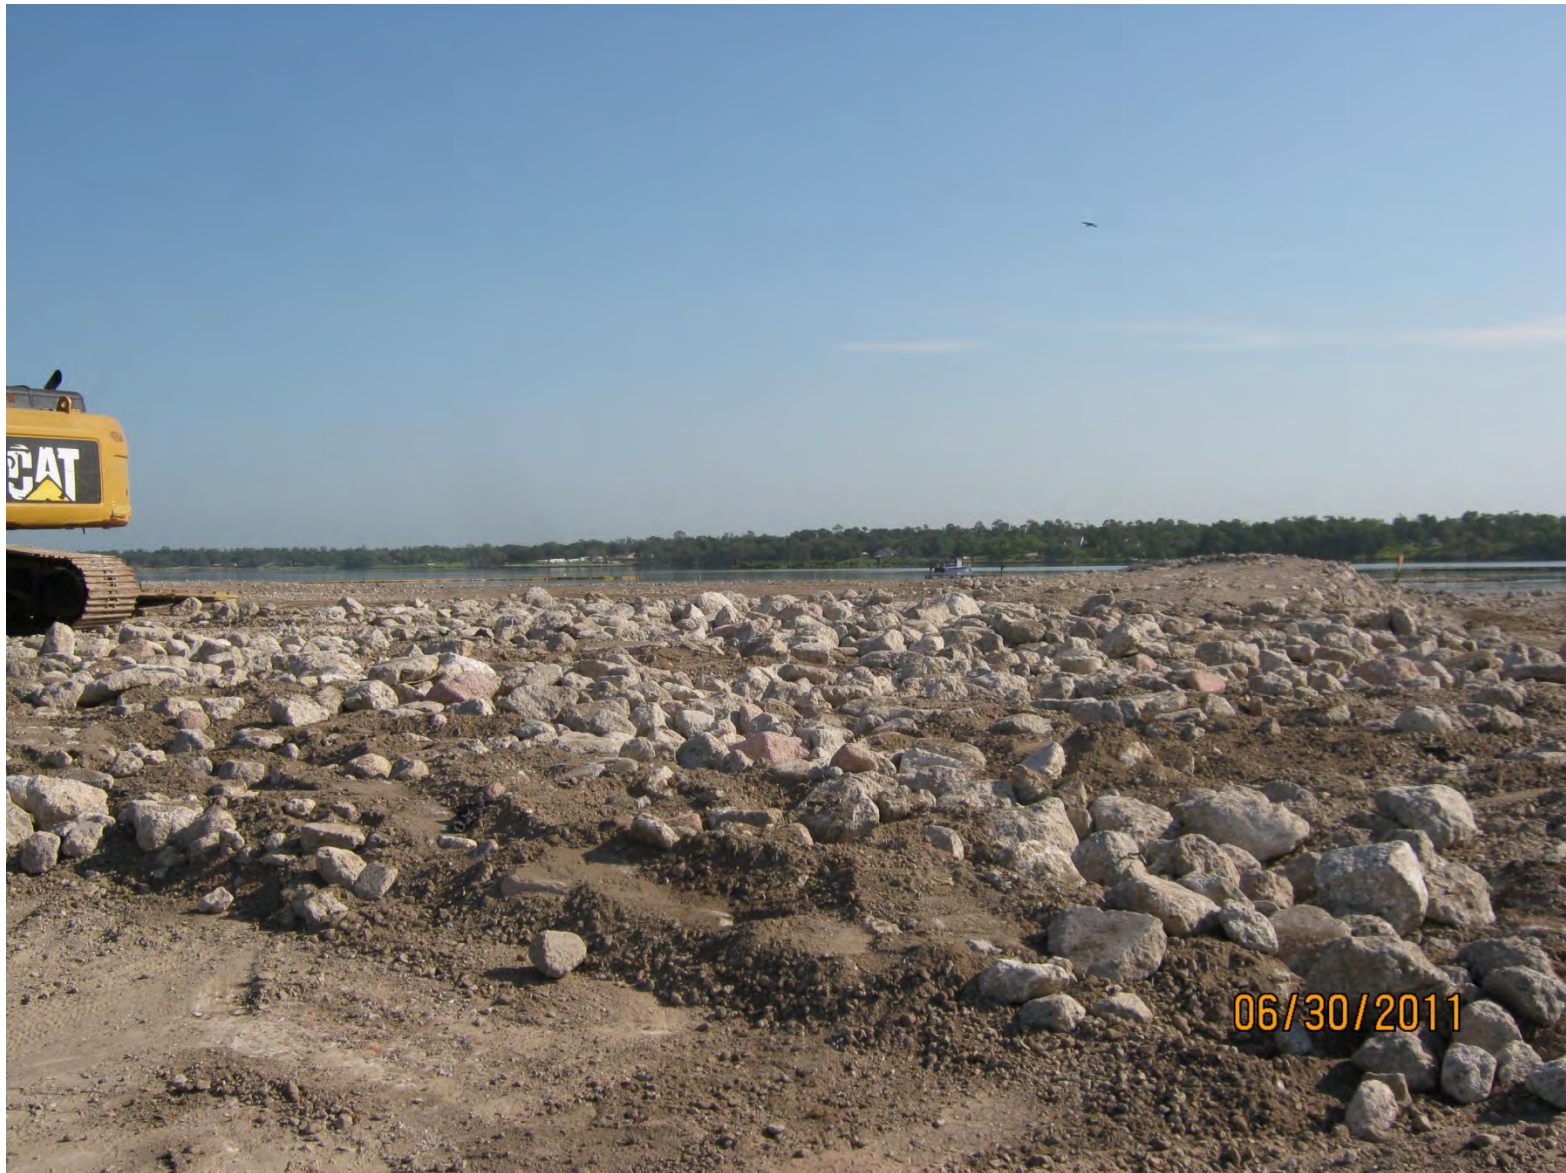
Final layer of armor stone placed over layer of geotextile. Looking north along central berm. Note reddish colored processed concrete aggregate.

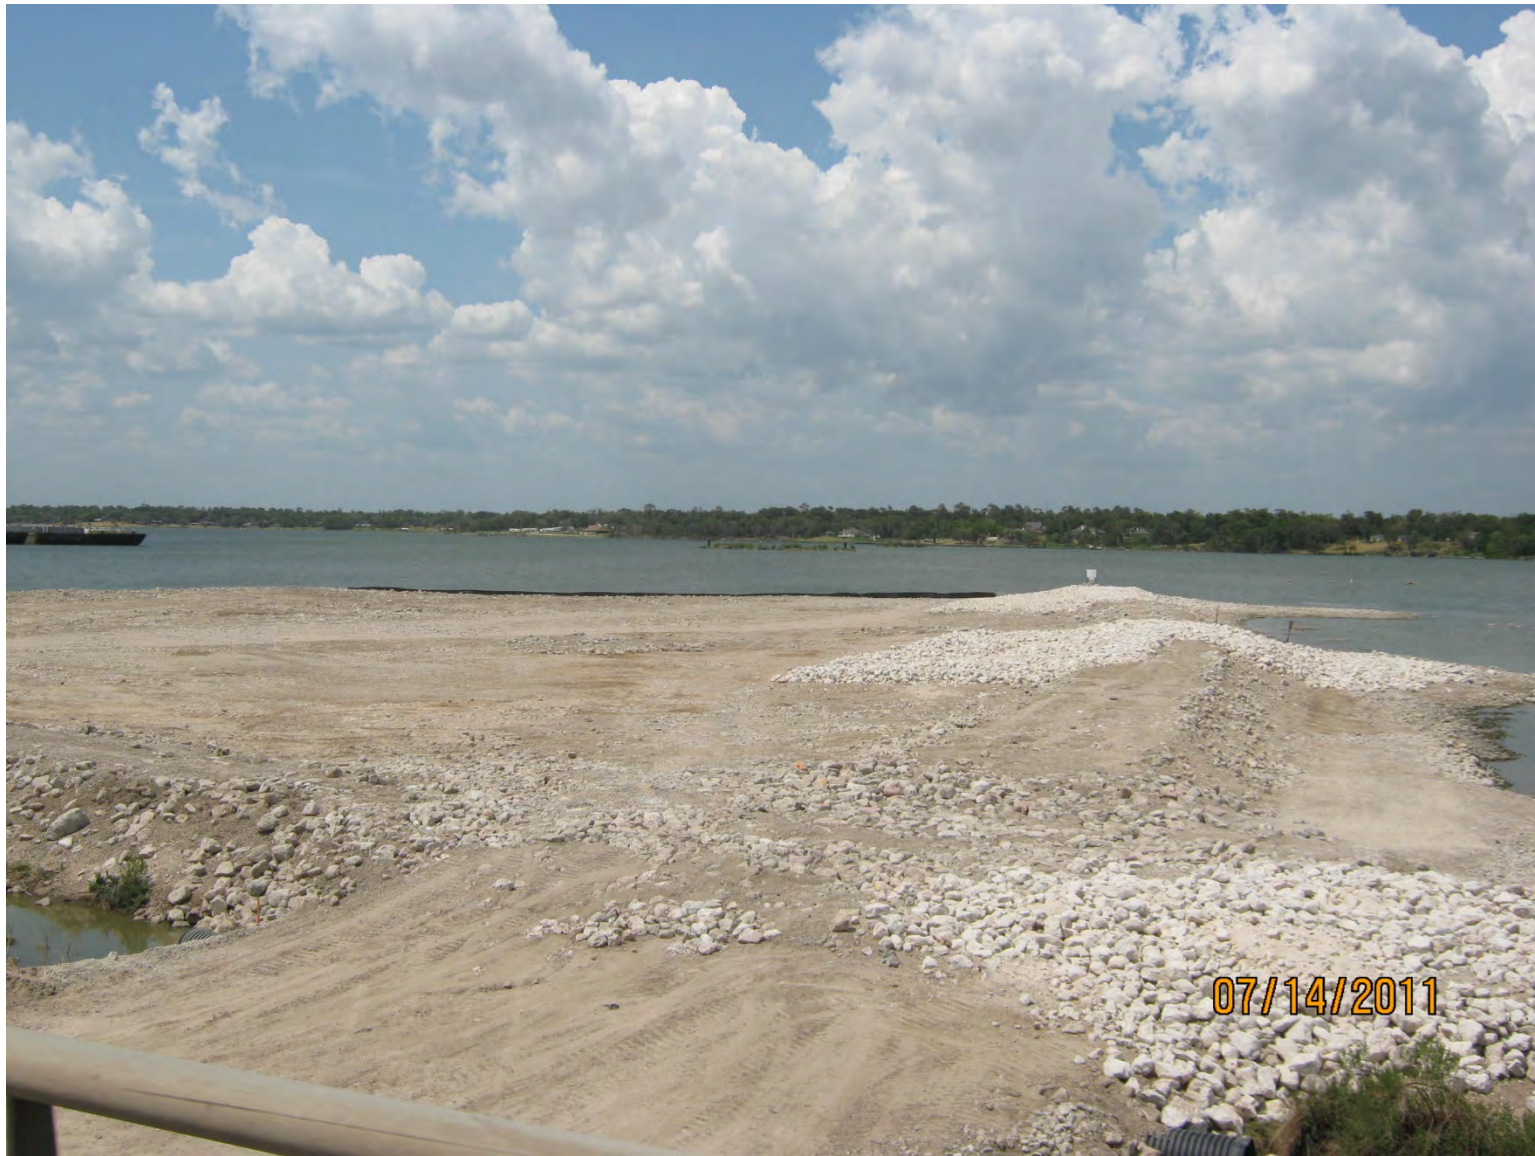
Project completion photo from I-10 Bridge. Note reddish colored processed concrete aggregates in the stockpile area.

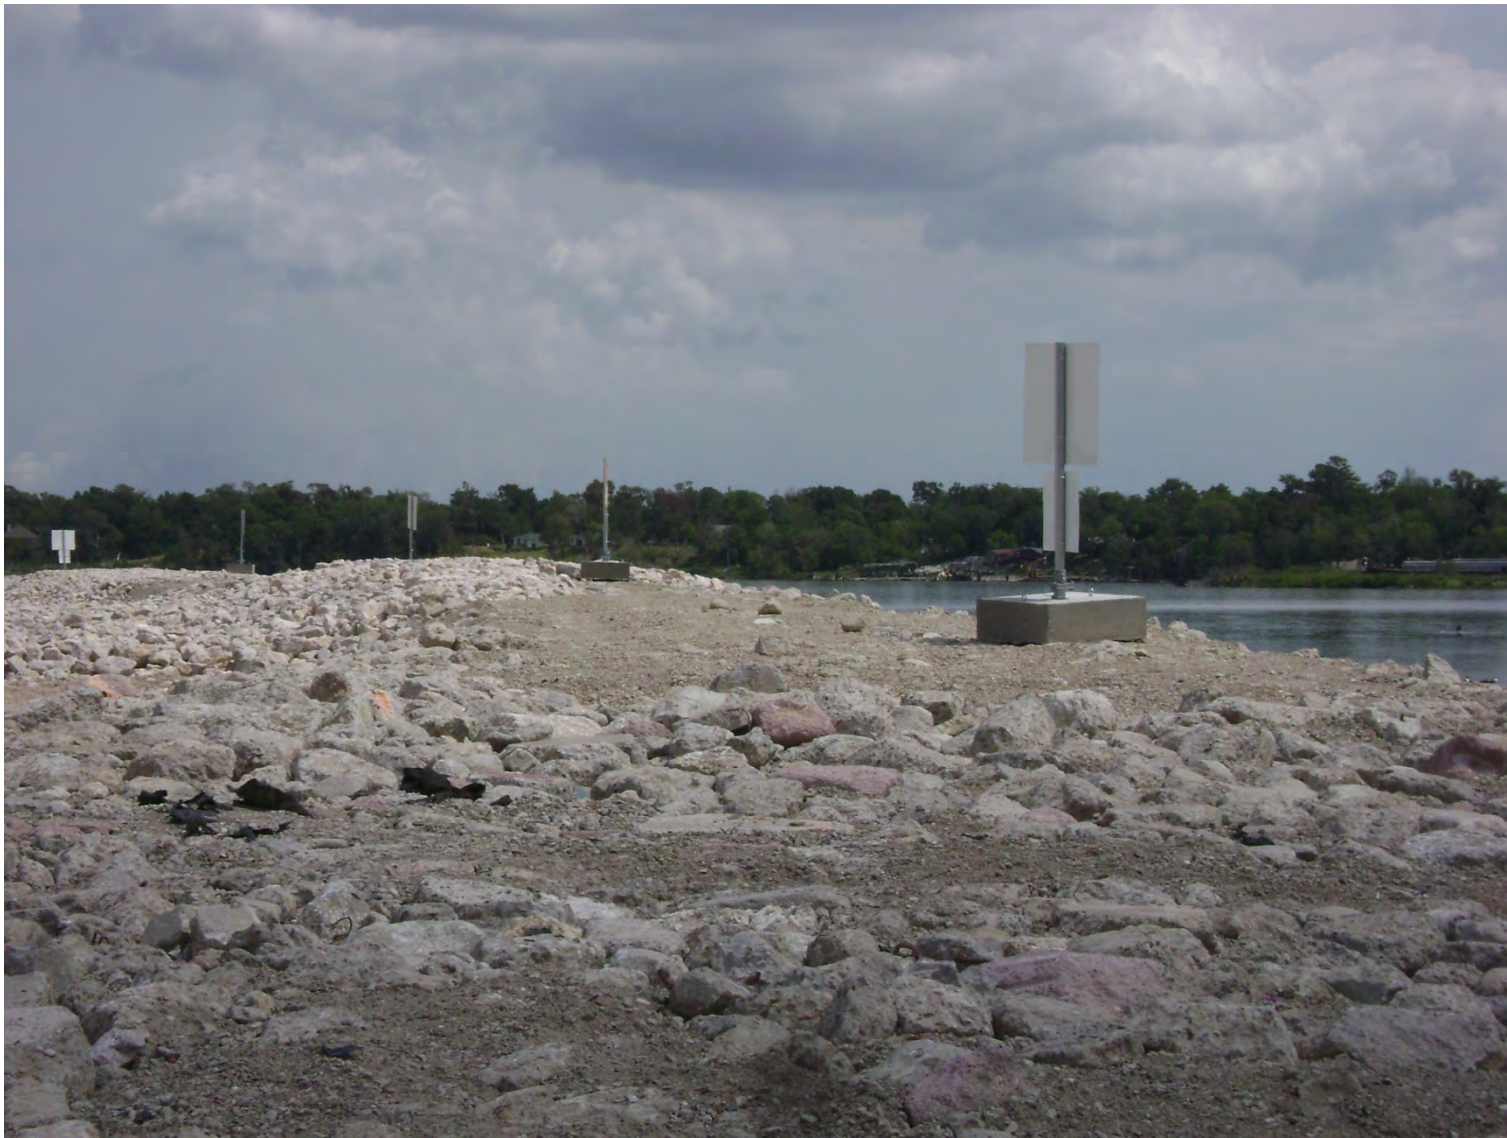
Project completion photo dated July 28, 2011 in the photo log. Note signage and reddish colored processed concrete aggregate along central berm with remnant geotextile from multiple laps for the 12 ounce geotextile underlayer, geomembrane, 16 ounce cushion layer and final layer of geotextile and armor stone.

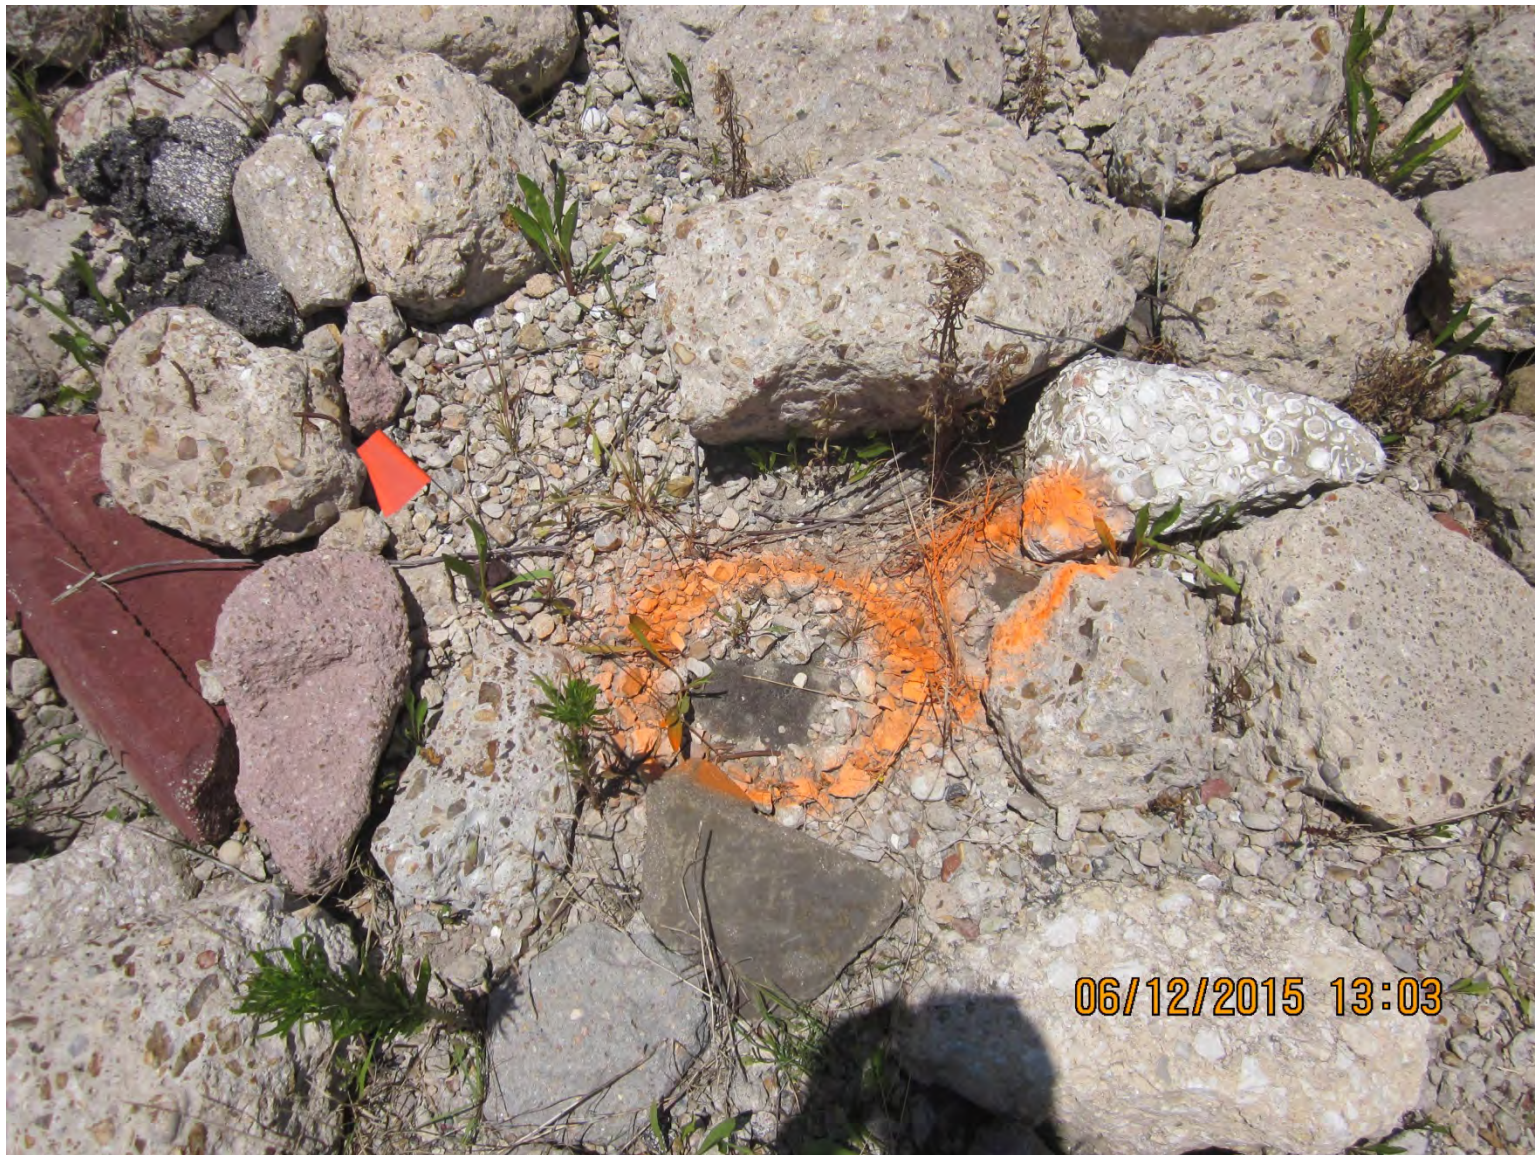
Photo of expose 3rd layer of geotextile atop the central berm stockpile area. Metal rod used to ping rock underneath.
